**Flood Control Project Maintenance
Levee Inspections**

Maintenance Issue Types Only, Levee Inspection Report By Mile - Spring 2016

Levee District No. 0003 (Glenn County)

Waterway	Bank	Unit Miles	Inspection Start/End	Inspector
Unit No. 01 Glenn County Sacramento River	Left	11.97	03/25/2016 03/25/2016	Keith Millard

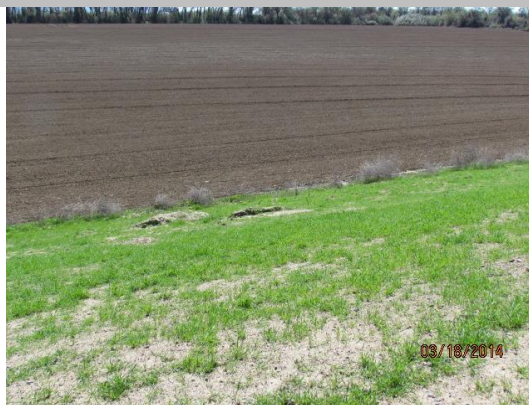
Photo 1 of 1 : SP_2016_LD0003_27_55_20160324_00032.jpg

View of the rodent activity along the w/s slope.

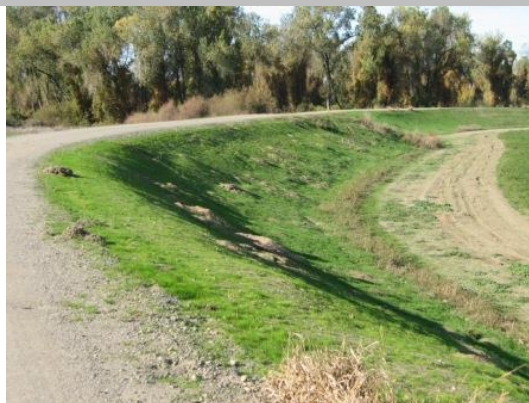
Photo 1 of 1 : SP_2016_LD0003_27_3_20160324_00001.jpg

LM Start	0.71	Rating **	U	Issue No.	3
LM End	0.75	Issue Type +	Ma	Location *	LS
Category	Earthen Levee			GPS Latitude/Longitude	
				Start	End
Item	Animal Control			39.388578 °	39.388323 °
				-121.997987 °	-121.998727 °
DWR ID	DWR_LD0003_01_s_2012_3				
Comment Code					
A3 : No rodents visible, but rodent burrows visible; need to backfill and compact or grout burrows.					
Inspector Comment

View of squirrel holes along the slope.

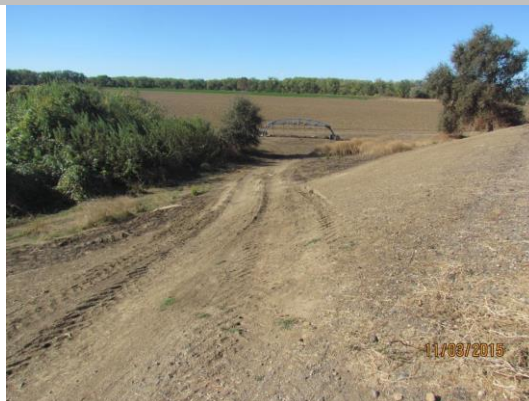
Photo 1 of 1 : SP_2016_LD0003_27_44_20160324_00023.jpg

LM Start	0.78	Rating **	M	Issue No.	44
LM End	0.78	Issue Type +	Ma	Location *	WS
Category	Earthen Levee			GPS Latitude/Longitude	
				Start	End
Item	Slope Stability			39.388440 °	39.388440 °
				-121.999175 °	-121.999175 °
DWR ID	DWR_LD0003_01_f_2015_44				
Comment Code					
S3 : Repair the levee slope damaged by vehicle traffic and prevent access where possible.					
Inspector Comment					
Repair the waterside slope damage caused by vehicle traffic.

View of the vehicle erosion along the waterside slope.

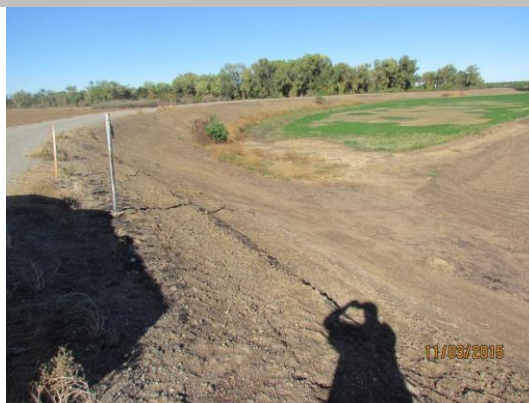
Photo 1 of 1 : SP_2016_LD0003_27_49_20160324_00026.jpg

LM Start	0.79	Rating **	M	Issue No.	49
LM End	0.79	Issue Type +	Ma	Location *	LS
Category	Earthen Levee			GPS Latitude/Longitude	
				Start	End
Item	Slope Stability			39.388508 °	39.388508 °
				-121.999407 °	-121.999407 °
DWR ID	DWR_LD0003_01_f_2015_49				
Comment Code					
S3 : Repair the levee slope damaged by vehicle traffic and prevent access where possible.					
Inspector Comment					
Repair the landside slope damaged by vehicle traffic.

View of the landside slope erosion caused by vehicle traffic.

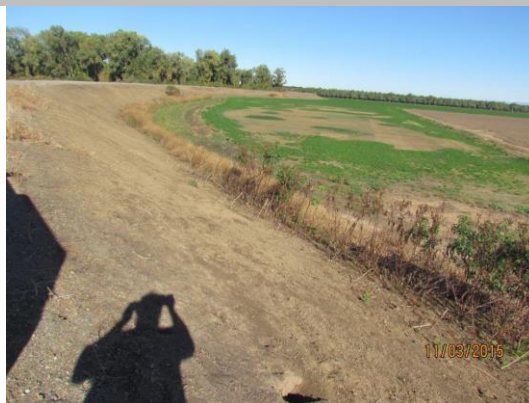
Photo 1 of 1 : SP_2016_LD0003_27_51_20160324_00029.jpg

LM Start	0.81	Rating **	U	Issue No.	51
LM End	0.91	Issue Type +	Ma	Location *	LS
Category	Earthen Levee			GPS Latitude/Longitude	
				Start	End
Item	Animal Control			39.388690 °	39.389867 °
				-121.999820 °	-122.000585 °
DWR ID	DWR_LD0003_01_f_2015_51				
Comment Code					
A3 : No rodents visible, but rodent burrows visible; need to backfill and compact or grout burrows.					
Inspector Comment					
Repair the rodent holes along the landside slope.

View of the rodent holes along the landside slope.

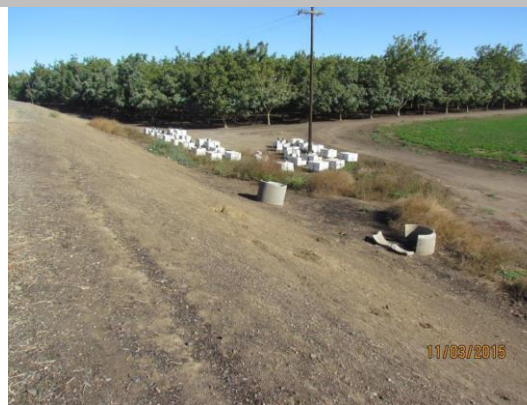
Photo 1 of 1 : SP_2016_LD0003_27_52_20160324_00030.jpg

LM Start	1.21	Rating **	M	Issue No.	52
LM End	1.21	Issue Type +	Ma	Location *	LS
Category	Earthen Levee			GPS Latitude/Longitude	
				Start	End
Item	Animal Control			39.394010 °	39.394010 °
				-122.000977 °	-122.000977 °
DWR ID	DWR_LD0003_01_f_2015_52				
Comment Code					
A3 : No rodents visible, but rodent burrows visible; need to backfill and compact or grout burrows.					
Inspector Comment					
Repair the rodent holes along the landside slope.

View of the rodent holes along the landside slope.

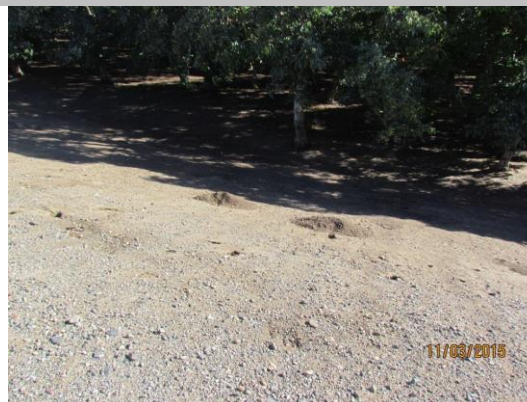
Photo 1 of 1 : SP_2016_LD0003_27_15_20160324_00012.jpg

LM Start	1.73	Rating **	U	Issue No.	15
LM End	2.41	Issue Type +	Ma	Location *	LS
Category	Earthen Levee			GPS Latitude/Longitude	
				Start	End
Item	Animal Control			39.401452 °	39.406557 °
				-122.002132 °	-121.995052 °
DWR ID	DWR_LD0003_01_s_2012_15				
Comment Code					
A3 : No rodents visible, but rodent burrows visible; need to backfill and compact or grout burrows.					
Inspector Comment					
Repair the rodent holes along the landside slope.

View of the rodent holes along the landside slope.

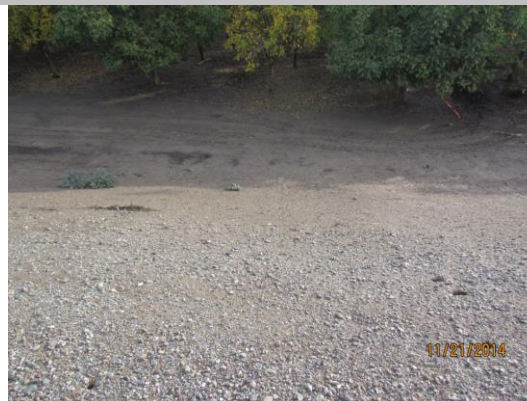
Photo 1 of 1 : SP_2016_LD0003_27_13_20160324_00010.jpg

View of the rodent holes along the waterside slope.

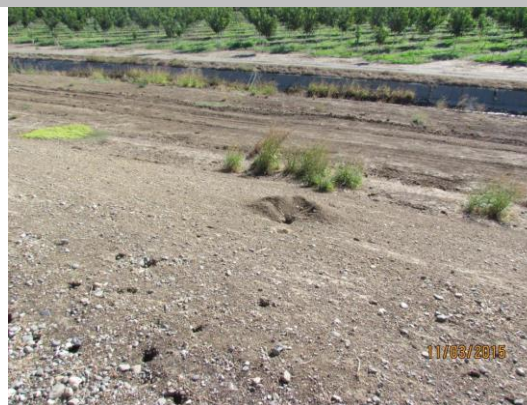
Photo 1 of 1 : SP_2016_LD0003_27_47_20160324_00024.jpg

LM Start	2.57	Rating **	U	Issue No.	47
LM End	2.57	Issue Type +	Ma	Location *	LS
Category	Earthen Levee			GPS Latitude/Longitude	
				Start	End
Item	Animal Control			39.407582 °	39.407582 °
				-121.992417 °	-121.992417 °
DWR ID	DWR_LD0003_01_f_2015_47				
Comment Code					
A3 : No rodents visible, but rodent burrows visible; need to backfill and compact or grout burrows.					
Inspector Comment					
Repair rodent hole on LS slope.

View of the rodent holes along the landside slope.

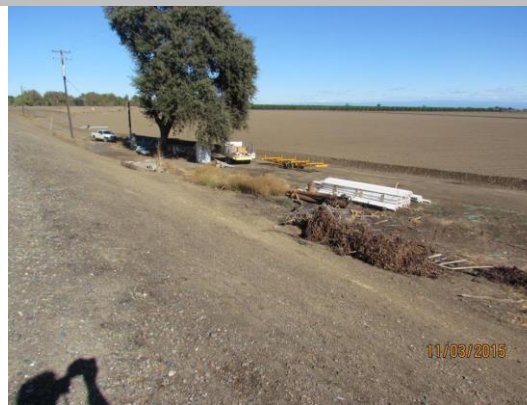
Photo 1 of 1 : SP_2016_LD0003_27_54_20160324_00031.jpg

LM Start	2.96	Rating **	U	Issue No.	54
LM End	3.09	Issue Type +	Ma	Location *	LS
Category	Earthen Levee			GPS Latitude/Longitude	
				Start	End
Item	Animal Control			39.412613 °	39.414392 °
				-121.991278 °	-121.992257 °
DWR ID	DWR_LD0003_01_f_2015_54				
Comment Code					
A1 : Exterminate rodents and backfill and compact or grout burrows.					
Inspector Comment					
Implement rodent control measures and repair rodent damage on LS slope.

View of the rodent holes along the landside slope.

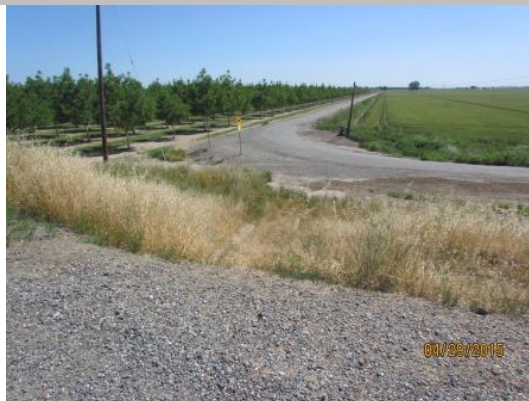
Photo 1 of 1 : SP_2016_LD0003_27_9_20160324_00005.jpg

LM Start	3.39	Rating **	M	Issue No.	9
LM End	3.39	Issue Type +	Ma	Location *	LS
Category	Earthen Levee			GPS Latitude/Longitude	
				Start	End
Item	Slope Stability			39.418382 °	39.418382 °
				-121.992480 °	-121.992480 °
DWR ID	DWR_LD0003_01_s_2012_9				
Comment Code					
S3 : Repair the levee slope damaged by vehicle traffic and prevent access where possible.					
Inspector Comment					
Repair the erosion along the landside slope and prevent vehicle access

View of the vehicle erosion along the landside slope.

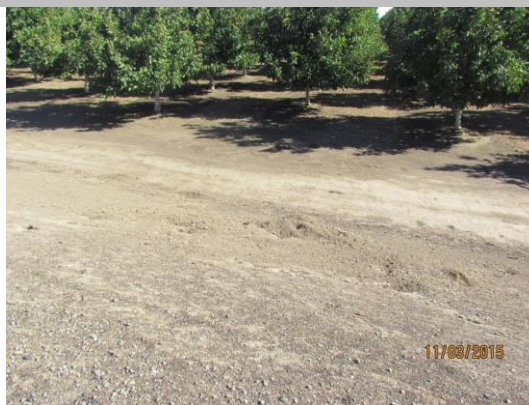
Photo 1 of 1 : SP_2016_LD0003_27_58_20160324_00034.jpg

LM Start	3.41	Rating **	U	Issue No.	58
LM End	3.48	Issue Type +	Ma	Location *	LS
Category	Earthen Levee			GPS Latitude/Longitude	
				Start	End
Item	Animal Control			39.418687 °	39.419762 °
				-121.992422 °	-121.992307 °
DWR ID	DWR_LD0003_01_f_2015_58				
Comment Code					
A3 : No rodents visible, but rodent burrows visible; need to backfill and compact or grout burrows.					
Inspector Comment					
Implement rodent control measures and repair rodent damage on LS slope.

View of the rodent. Holes along the landside slope.

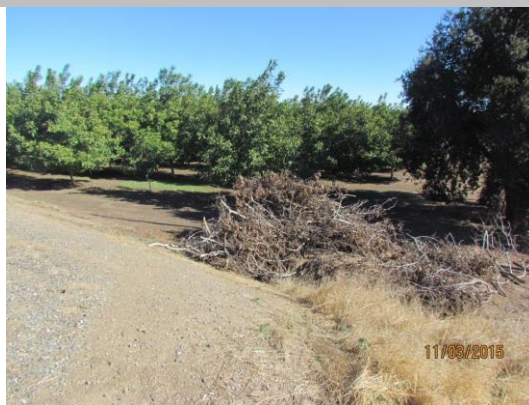
Photo 1 of 1 : SP_2016_LD0003_27_66_20160324_00041.jpg

LM Start	4.33	Rating **	M	Issue No.	66
LM End	4.33	Issue Type +	Ma	Location *	LS
Category	Earthen Levee			GPS Latitude/Longitude	
				Start	End
Item	Encroachments			39.430927 °	39.430927 °
				-121.987142 °	-121.987142 °
DWR ID	DWR_LD0003_01_f_2015_66				
Comment Code					
PR : Prunings					
Inspector Comment					
Remove prunings from LS toe.

View of the prunings along the landside toe.

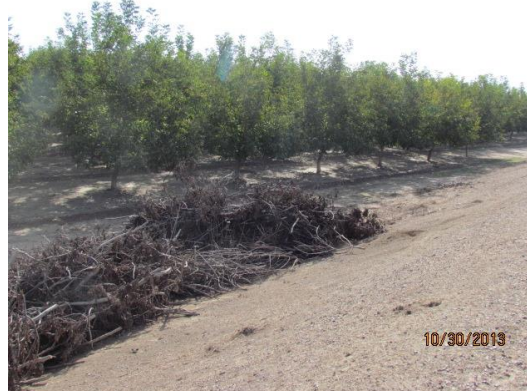
Photo 1 of 1 : SP_2016_LD0003_27_63_20160324_00039.jpg

View of the prunings along the landside toe.

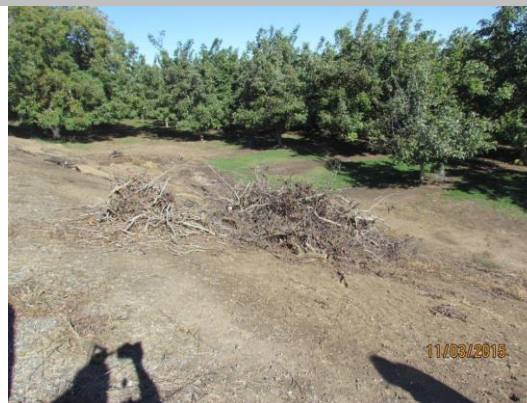
Photo 1 of 1 : SP_2016_LD0003_27_69_20160324_00044.jpg

View of the prunings along the landside slope.

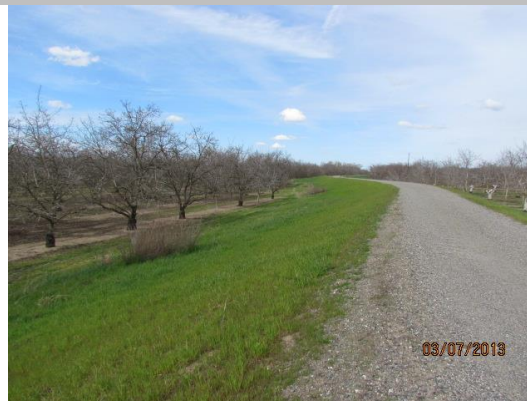
Photo 1 of 2 : SP_2016_LD0003_27_21_20160324_00014.jpg

View of no rodent activity.

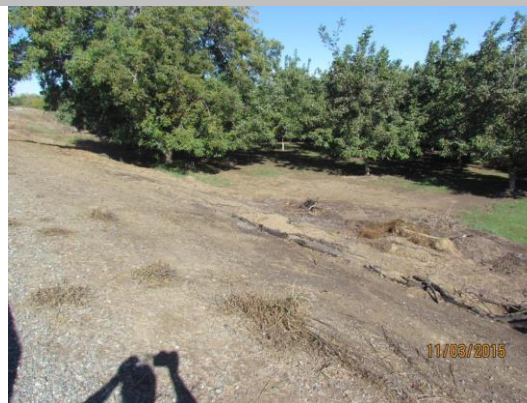
Photo 2 of 2 : SP_2016_LD0003_27_21_20160324_00015.jpg

View of the rodent holes along the landside slope.

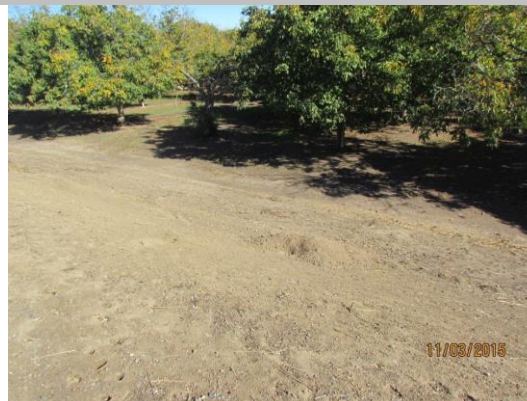
Photo 1 of 1 : SP_2016_LD0003_27_70_20160324_00045.jpg

LM Start	5.39	Rating **	U	Issue No.	70
LM End	5.39	Issue Type +	Ma	Location *	LS
Category	Earthen Levee			GPS Latitude/Longitude	
				Start	End
Item	Animal Control			39.445808 °	39.445808 °
				-121.991552 °	-121.991552 °
DWR ID	DWR_LD0003_01_f_2015_70				
Comment Code					
A3 : No rodents visible, but rodent burrows visible; need to backfill and compact or grout burrows.					
Inspector Comment					
Remove the rodent holes along the landside slope.

View of the rodent holes along the landside slope.

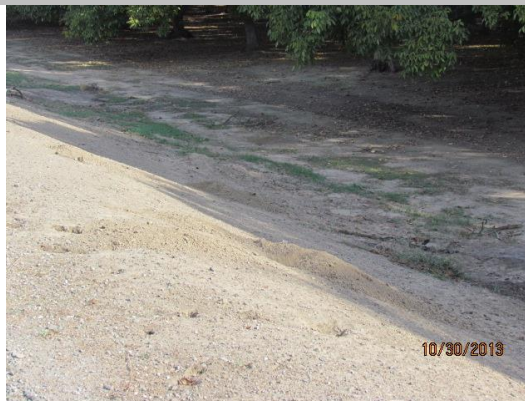
Photo 1 of 1 : SP_2016_LD0003_27_62_20160324_00038.jpg

View of the rodent holes along the landside slope.

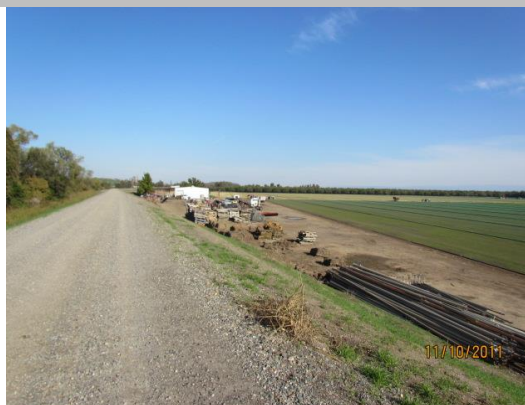
Photo 1 of 1 : SP_2016_LD0003_27_25_20160324_00016.jpg

LM Start	5.77	Rating **	M	Issue No.	25
LM End	5.88	Issue Type +	Ma	Location *	LS
Category	Earthen Levee			GPS Latitude/Longitude	
				Start	End
Item	Encroachments			39.451293 °	39.452872 °
				-121.992370 °	-121.992897 °
DWR ID	DWR_LD0003_01_s_2012_25				
Comment Code					
AV : Abandoned vehicles					
Inspector Comment

View of the equipment along the L/S toe.

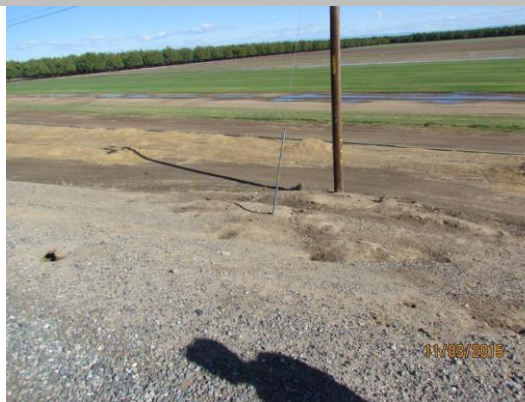
Photo 1 of 1 : SP_2016_LD0003_27_71_20160324_00046.jpg

LM Start	6.06	Rating **	U	Issue No.	71
LM End	6.06	Issue Type +	Ma	Location *	LS
Category	Earthen Levee			GPS Latitude/Longitude	
				Start	End
Item	Animal Control			39.455313 °	39.455313 °
				-121.993712 °	-121.993712 °
DWR ID	DWR_LD0003_01_f_2015_71				
Comment Code					
A3 : No rodents visible, but rodent burrows visible; need to backfill and compact or grout burrows.					
Inspector Comment					
Repair rodent damage on LS slope.

View of the rodent holes along the landside slope.

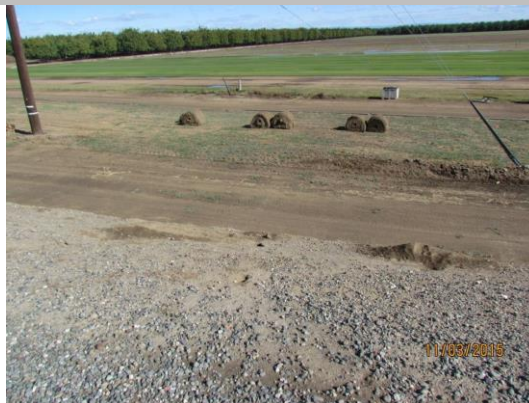
Photo 1 of 1 : SP_2016_LD0003_27_72_20160324_00047.jpg

LM Start	6.11	Rating **	U	Issue No.	72
LM End	6.11	Issue Type +	Ma	Location *	LS
Category	Earthen Levee			GPS Latitude/Longitude	
				Start	End
Item	Animal Control			39.456018 °	39.456018 °
				-121.993772 °	-121.993772 °
DWR ID	DWR_LD0003_01_f_2015_72				
Comment Code					
A3 : No rodents visible, but rodent burrows visible; need to backfill and compact or grout burrows.					
Inspector Comment					
Repair rodent damage on LS slope

View of the rodent holes along the landside slope.

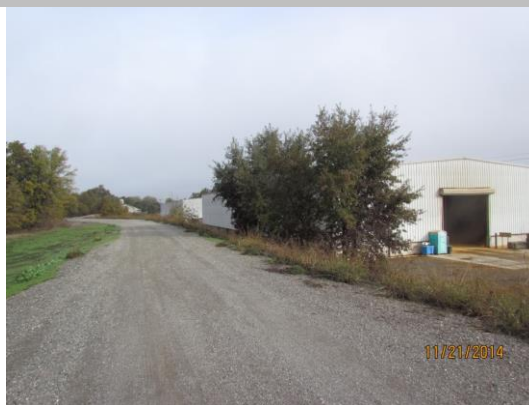
Photo 1 of 1 : SP_2016_LD0003_27_7_20160324_00004.jpg

LM Start	6.24	Rating **	M	Issue No.	7
LM End	6.38	Issue Type +	Ma	Location *	LS
Category	Earthen Levee			GPS Latitude/Longitude	
				Start	End
Item	Trim / Thin Trees			39.457968 °	39.459955 °
				-121.993712 °	-121.993512 °
DWR ID	DWR_LD0003_01_s_2012_7				
Comment Code					
T1 : Trim trees to at least five feet above ground level.					
Inspector Comment

Trim the trees 5 feet for better visibility.

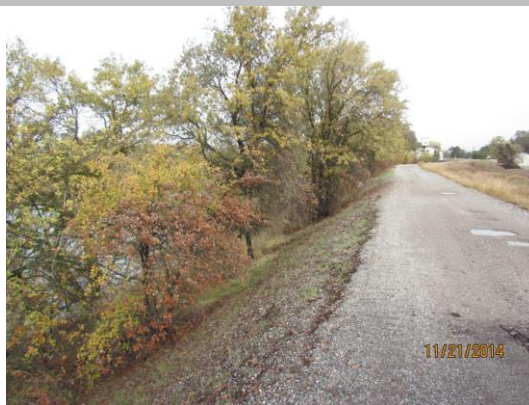
Photo 1 of 1 : SP_2016_LD0003_27_48_20160324_00025.jpg

LM Start	6.29	Rating **	M	Issue No.	48
LM End	6.38	Issue Type +	Ma	Location *	WS
Category	Earthen Levee			GPS Latitude/Longitude	
				Start	End
Item	Trim / Thin Trees			39.458587 °	39.459912 °
				-121.993777 °	-121.993592 °
DWR ID	DWR_LD0003_01_s_2012_48				
Comment Code					
T1 : Trim trees to at least five feet above ground level.					
Inspector Comment

Trim the trees up 5 feet for better visibility.

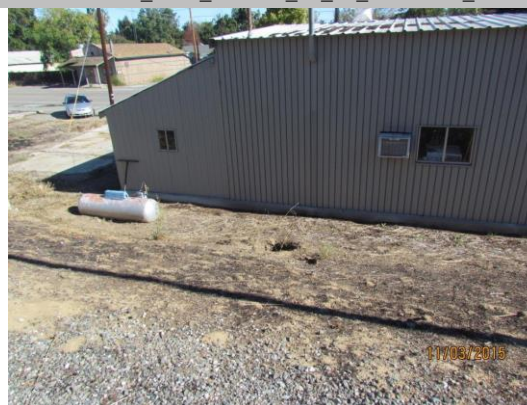
Photo 1 of 1 : SP_2016_LD0003_27_76_20160324_00051.jpg

LM Start	6.61	Rating **	U	Issue No.	76
LM End	6.61	Issue Type +	Ma	Location *	LS
Category	Earthen Levee			GPS Latitude/Longitude	
				Start	End
Item	Trim / Thin Trees			39.463185 °	39.463185 °
				-121.992657 °	-121.992657 °
DWR ID	DWR_LD0003_01_f_2015_76				
Comment Code					
T5 : Tree stumps.					
Inspector Comment					
Repair the burned out stump hole along the landside toe.

View of the burned out stump hole along the landside toe.

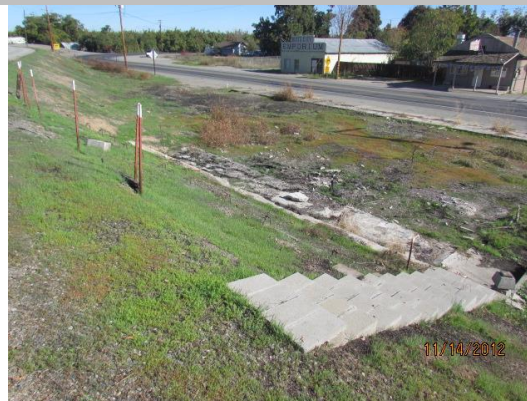
Photo 1 of 1 : SP_2016_LD0003_27_12_20160324_00009.jpg

LM Start	6.63	Rating **	M	Issue No.	12
LM End	6.63	Issue Type +	Ma	Location *	LS
Category	Earthen Levee			GPS Latitude/Longitude	
				Start	End
Item	Slope Stability			39.463366 °	39.463366 °
				-121.992586 °	-121.992586 °
DWR ID	DWR_LD0003_01_f_2012_12				
Comment Code					
S1 : Repair slope instability.					
Inspector Comment					
Building has burned down.

View of concrete stairs & foundation along the slope of the levee.

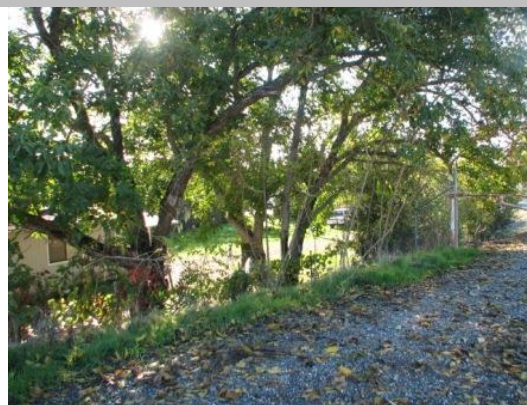
Photo 1 of 1 : SP_2016_LD0003_27_35_20160324_00019.jpg

View of the trees that are hanging over the landside slope of the levee.

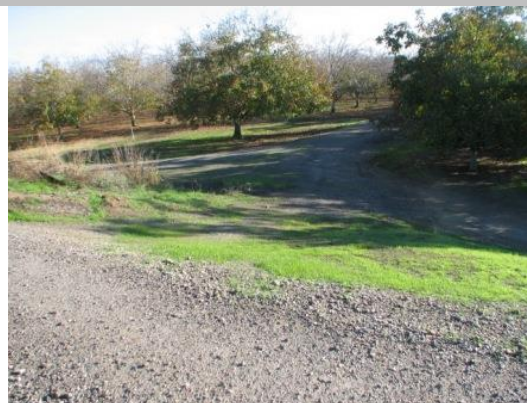
Photo 1 of 1 : SP_2016_LD0003_27_14_20160324_00011.jpg

LM Start	7.21	Rating **	M	Issue No.	14
LM End	7.21	Issue Type +	Ma	Location *	LS
Category	Earthen Levee			GPS Latitude/Longitude	
				Start	End
Item	Slope Stability			39.471658 °	39.471658 °
				-121.991245 °	-121.991245 °
DWR ID	DWR_LD0003_01_s_2012_14				
Comment Code					
S3 : Repair the levee slope damaged by vehicle traffic and prevent access where possible.					
Inspector Comment

Vehicle erosion along the slope.

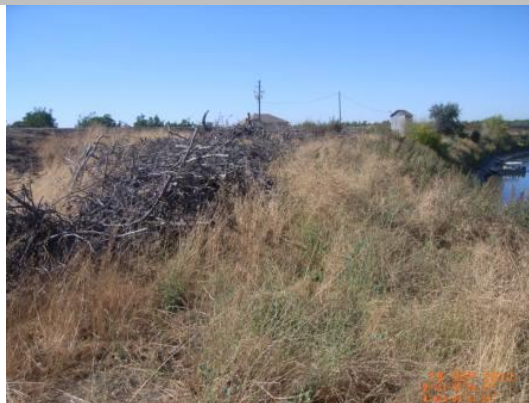
Photo 1 of 1 : SP_2016_LD0003_27_60_20160324_00036.jpg

View of the prunings along the landside toe.

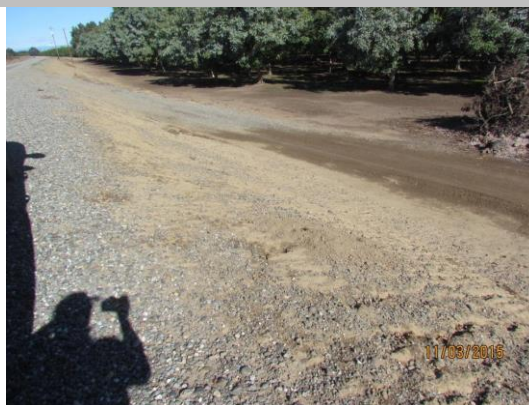
Photo 1 of 1 : SP_2016_LD0003_27_78_20160324_00053.jpg

LM Start	9.23	Rating **	M	Issue No.	78
LM End	9.23	Issue Type +	Ma	Location *	LS
Category	Earthen Levee			GPS Latitude/Longitude	
				Start	End
Item	Animal Control			39.498897 °	39.498897 °
				-121.986827 °	-121.986827 °
DWR ID	DWR_LD0003_01_f_2015_78				
Comment Code					
A1 : Exterminate rodents and backfill and compact or grout burrows.					
Inspector Comment					
Repair rodent hole on LS shoulder.

View of the rodent holes along the landside slope.

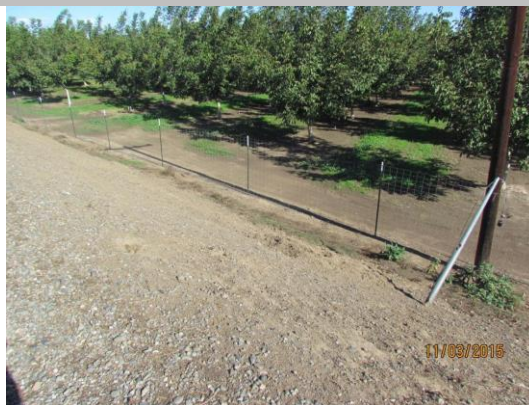
Photo 1 of 1 : SP_2016_LD0003_27_79_20160324_00054.jpg

LM Start	9.50	Rating **	U	Issue No.	79
LM End	9.50	Issue Type +	Ma	Location *	LS
Category	Earthen Levee			GPS Latitude/Longitude	
				Start	End
Item	Animal Control			39.502698 °	39.502698 °
				-121.985235 °	-121.985235 °
DWR ID	DWR_LD0003_01_f_2015_79				
Comment Code					
A3 : No rodents visible, but rodent burrows visible; need to backfill and compact or grout burrows.					
Inspector Comment					
Repair rodent damage on LS slope.

View of the rodent holes along the landside slope.

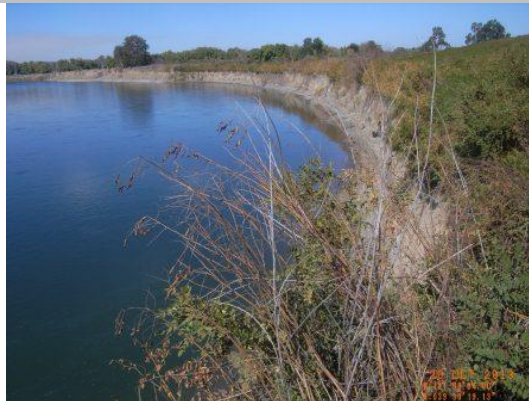
Photo 1 of 3 : SP_2016_LD0003_27_10_20160324_00006.jpg

2007 - Getting close to the levee. Bank is clayey silt with clayey/silty toe. 2008 - Looks a little worse at the upstream end. 2009 - Some new erosion and slumping. 2010 - Some new erosion upstream of site, actively eroding at low flow. New bank swallow colony noted. 2011 - Significant erosion since last year, with an estimated 10 to 15 feet of berm lost. Large sections of the bank have slumped off. 2012 - Part of the site appears to be stabilizing, but still minor slumping in other locations. 2013 - Minor new erosion at toe. 2015: Last observed in 2013. [2015 Site ID: SAC_172-0_L] On 3/25/2016, recent high water caused river to erode to within 10-20 feet of levee toe. Appears still somewhat active.

USACE 2013 Photo #1

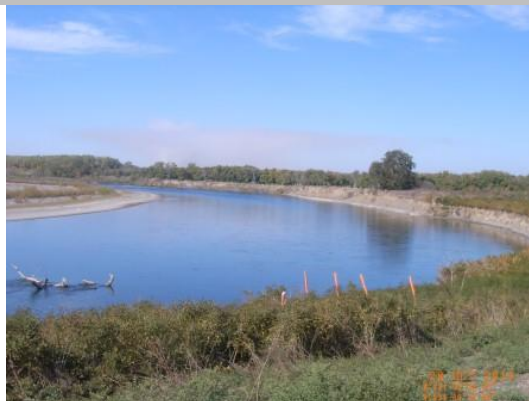
Photo 2 of 3 : SP_2016_LD0003_27_10_20160324_00007.jpg

USACE 2013 Photo #2

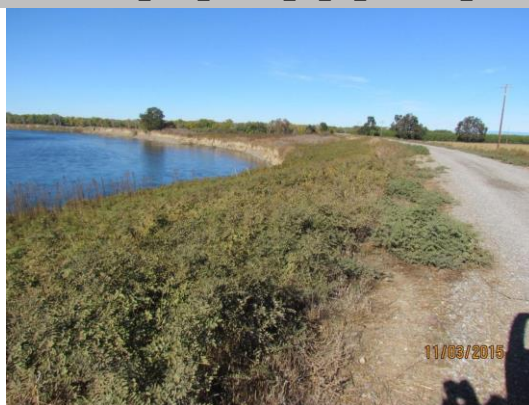
Photo 1 of 1 : SP_2016_LD0003_27_80_20160324_00055.jpg

View of the vegetation along the waterside slope and toe.

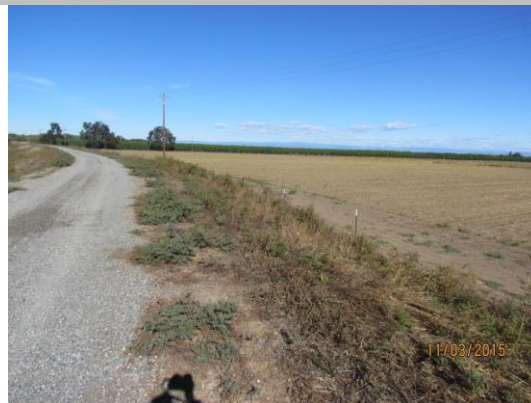
Photo 1 of 1 : SP_2016_LD0003_27_81_20160324_00056.jpg

View of the vegetation along the landside slope.

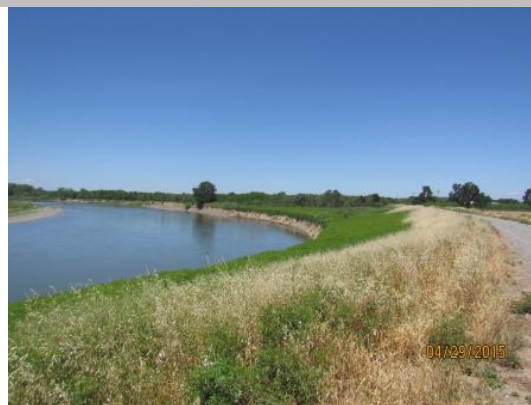
Photo 1 of 4 : SP_2016_LD0003_27_50_20160324_00027.jpg

LM Start	9.70	Rating **	U	Issue No.	50
LM End	9.70	Issue Type +	Ma	Location *	WS
Category	Earthen Levee			GPS Latitude/Longitude	
				Start	End
Item	Erosion / Bank Caving			39.505435 °	39.505435 °
				-121.984172 °	-121.984172 °
DWR ID	DWR_LD0003_01_f_2014_50				
Comment Code					
E2 : Schedule repair of erosion site prior to the next inspection.					
Inspector Comment					
Repair the erosion along the waterside toe. On 3/25/2016, recent high water caused river to erode to within 10-20 feet of levee toe. Appears still somewhat active.

View of erosion along the waterside toe. Same site as the USACE erosion issue.

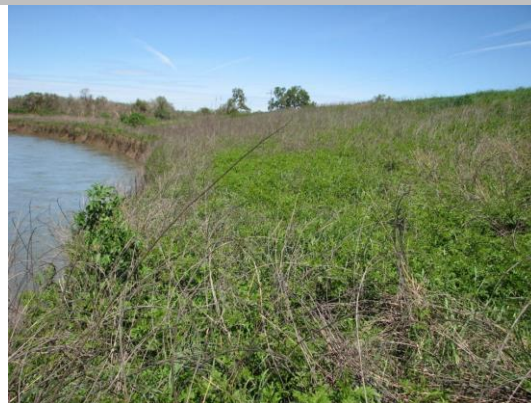
Photo 2 of 4 : SP_2016_LD0003_27_50_20160411_00101.jpg

View of erosion along the waterside toe. Same site as the USACE erosion issue. Photo 3/25/2016

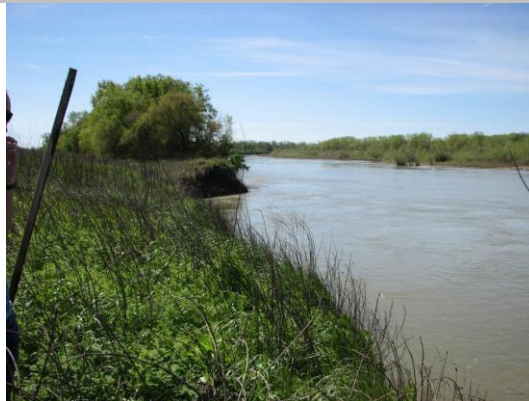
Photo 3 of 4 : SP_2016_LD0003_27_50_20160411_00103.jpg

LM Start	9.70	Rating **	U	Issue No.	50 (cont)	
LM End	9.70	Issue Type +	Ma	Location *	WS	
Category	Earthen Levee			GPS Latitude/Longitude		
				Start		End
Item	Erosion / Bank Caving			39.505435 °	39.505435 °	
				-121.984172 °	-121.984172 °	
DWR ID	DWR_LD0003_01_f_2014_50					
Comment Code						
E2 : Schedule repair of erosion site prior to the next inspection.						
Inspector Comment						
Repair the erosion along the waterside toe. On 3/25/2016, recent high water caused river to erode to within 10-20 feet of levee toe. Appears still somewhat active.

View of erosion along the waterside toe, downstream. Same site as the USACE erosion issue. Photo 3/25/2016

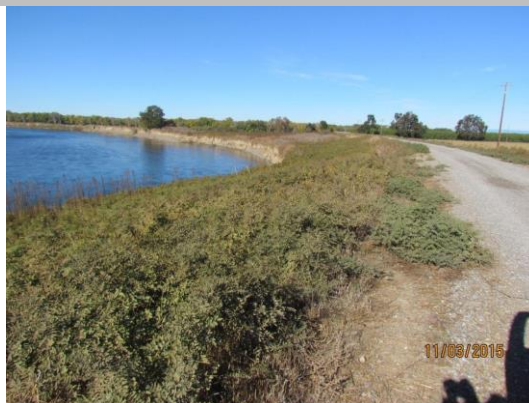
Photo 4 of 4 : SP_2016_LD0003_27_50_20160324_00028.jpg

View of the erosion along the waterside toe. Same site as the USACE erosion issue.

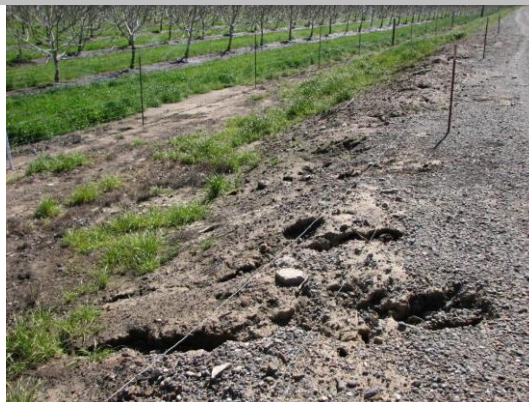
Photo 1 of 1 : SP_2016_LD0003_27_87_20160405_00100.jpg

LM Start	10.11	Rating **	M	Issue No.	87
LM End	10.11	Issue Type +	Ma	Location *	LS
Category	Earthen Levee			GPS Latitude/Longitude	
				Start	End
Item	Slope Stability			39.511450 °	39.511450 °
				-121.983930 °	-121.983930 °
DWR ID	DWR_LD0003_01_s_2016_87				
Comment Code					
S1 : Repair slope instability.					
Inspector Comment					
Repair water erosion rut on L/S slope.

Erosion ruts on l/s slope

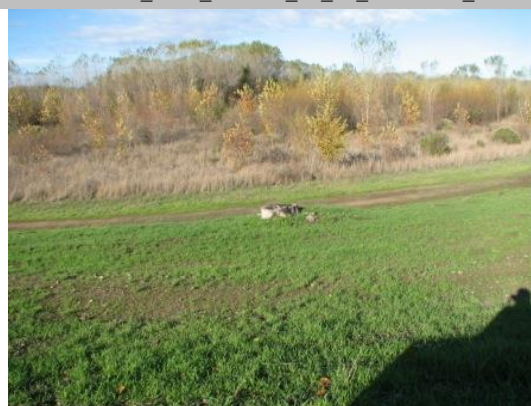
Photo 1 of 1 : SP_2016_LD0003_27_29_20160324_00017.jpg

View of the stump along the toe.

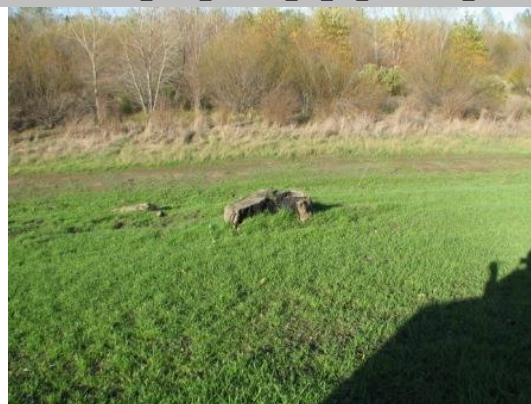
Photo 1 of 1 : SP_2016_LD0003_27_30_20160324_00018.jpg

View of the stump along the slope.

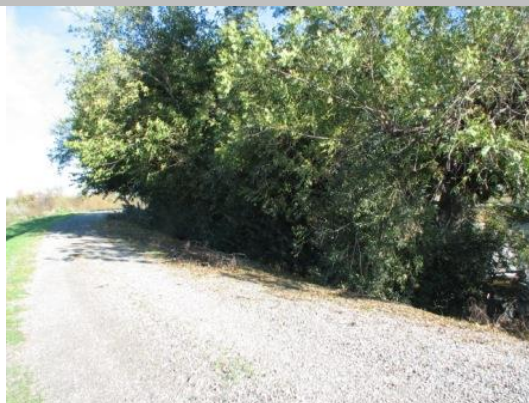
Photo 1 of 1 : SP_2016_LD0003_27_4_20160324_00002.jpg

View of the trees along the slope.

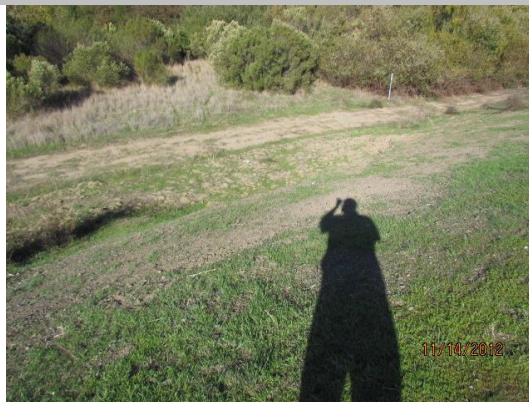
Photo 1 of 1 : SP_2016_LD0003_27_6_20160324_00003.jpg

LM Start	11.04	Rating **	M	Issue No.	6
LM End	11.04	Issue Type +	Ma	Location *	WS
Category	Earthen Levee			GPS Latitude/Longitude	
				Start	End
Item	Slope Stability			39.522921 °	39.522921 °
				-121.979172 °	-121.979172 °
DWR ID	DWR_LD0003_01_f_2012_6				
Comment Code					
S1 : Repair slope instability.					
Inspector Comment

View of the vertical cut along the w/s toe.
